## A Survey of Thatched Buildings in Scotland

Thatch Survey of Scotland  
2014-15

A photographic survey of thatched buildings in Scotland, surveyed between May 2014 and August 2015 by Zoe Herbert (SPAB Scotland Officer), on behalf of the Society for the Protection of Ancient Buildings.

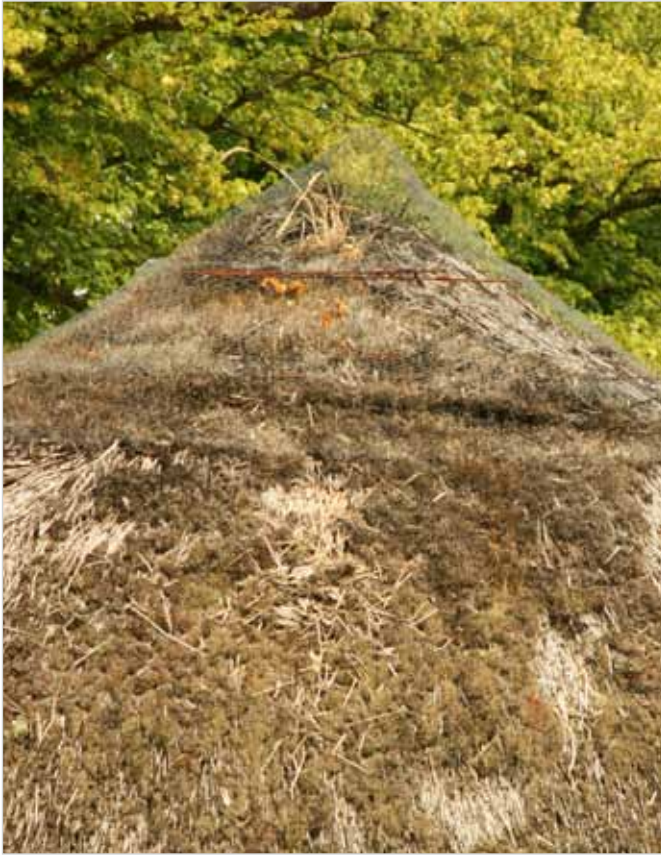
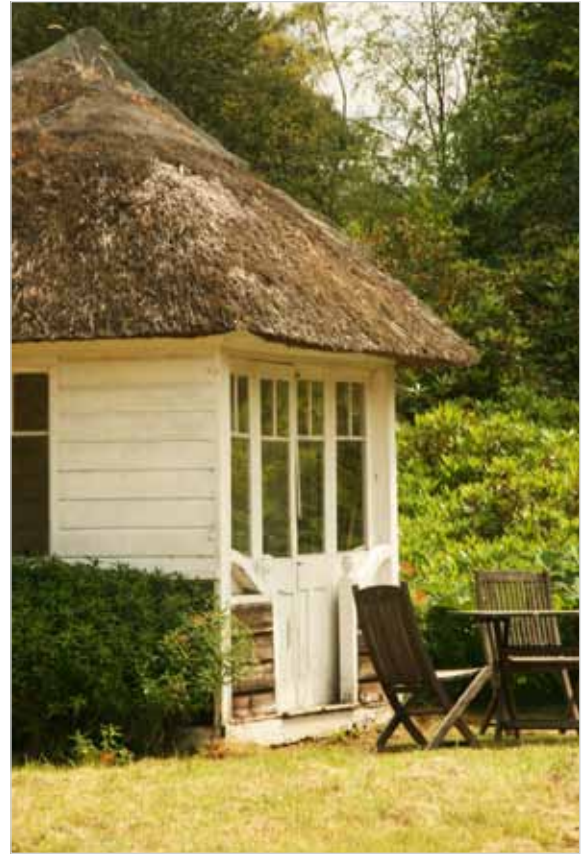
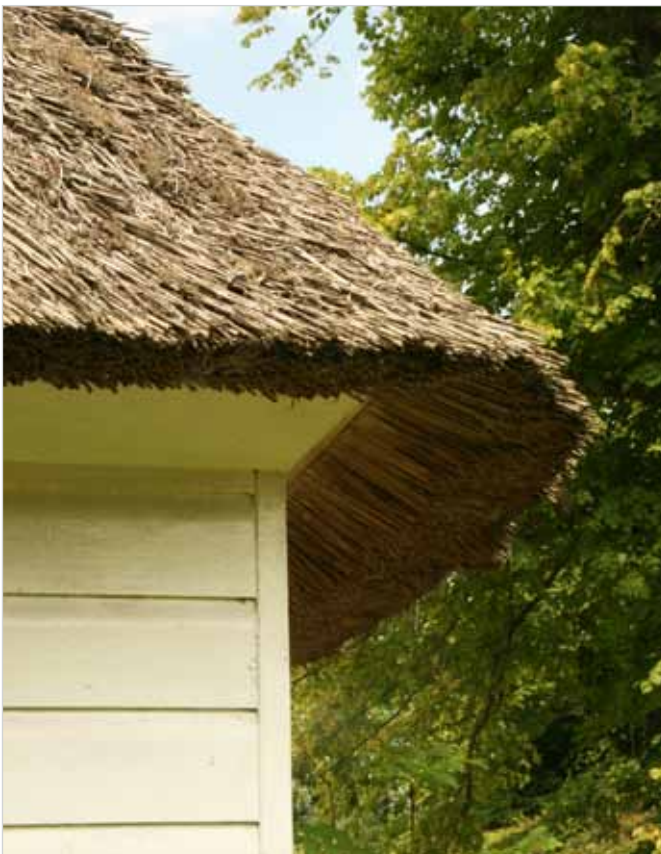
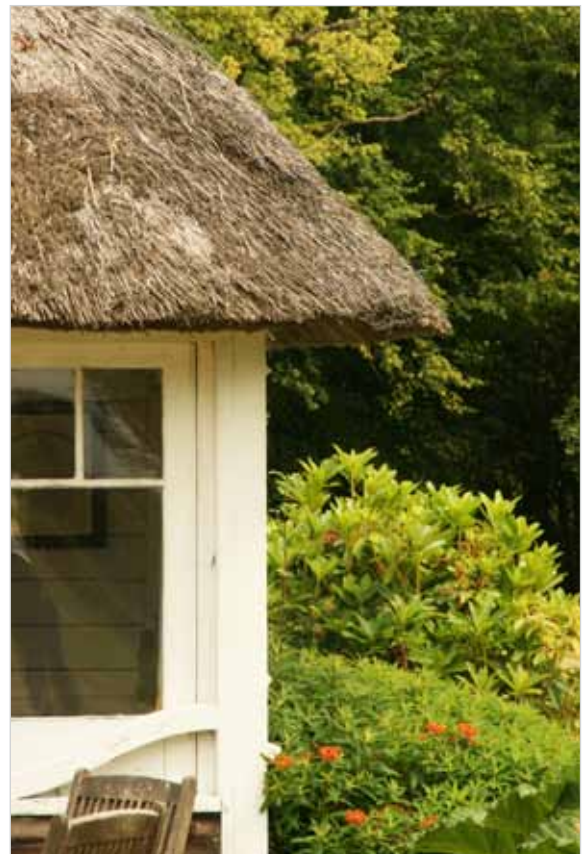
Finnich Malise – Stirling

Additional Notes: ..... Located within the grounds (to the south) of a large 19th-century mansion. Listed as an 'early 20th century square-plan boarded timber summerhouse with pyramidal thatched roof and overhanging eaves'. Its listing also states, interestingly that it was 'formerly built onto a wheel mechanism which allowed the summerhouse to be rotated'. The structure is periodically used by the building owners and is in a good condition. The owner stated that they moved into the house in 1991, and had the summerhouse re-thatched in reed around 1992-3. The owner does not remember the name of the thatcher but noted that the reed came

from 'somewhere in England'. The thatch is netted around the top and also has a strip of netting down one corner. It is in fairly good condition with only some minor pieces of loose thatch in places.

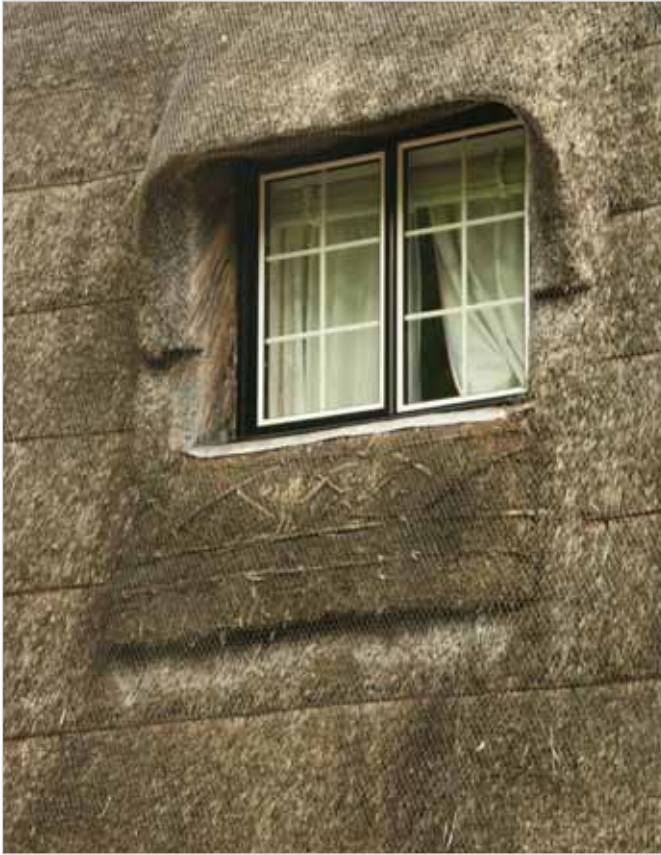
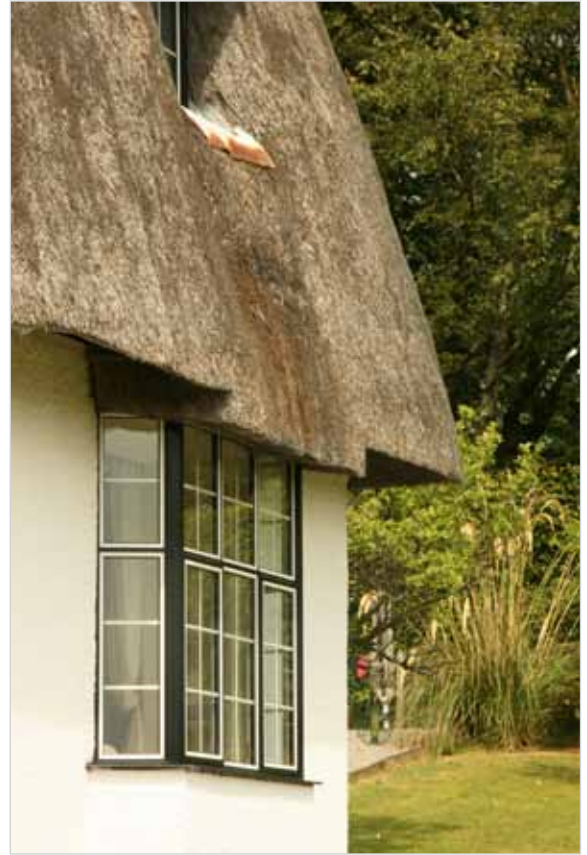
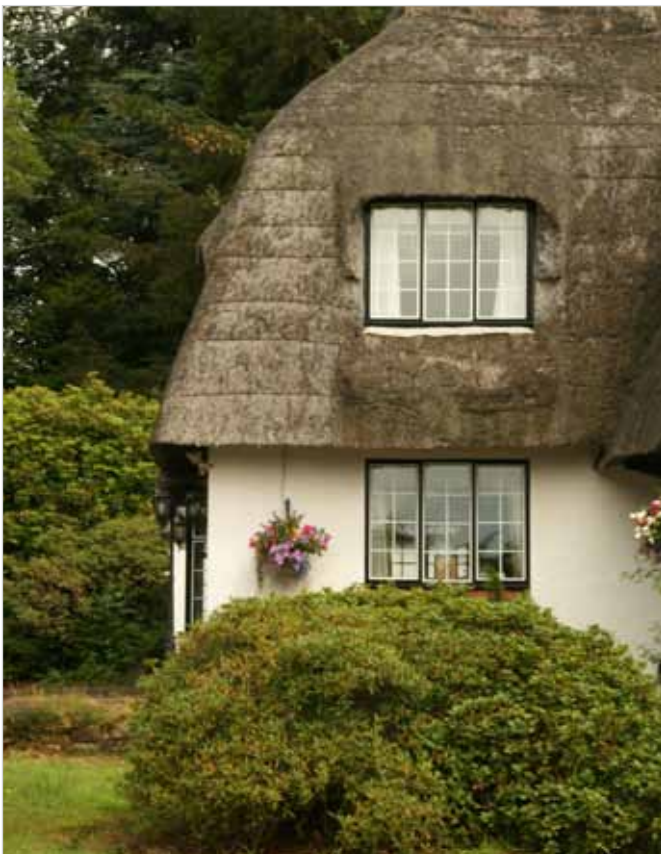
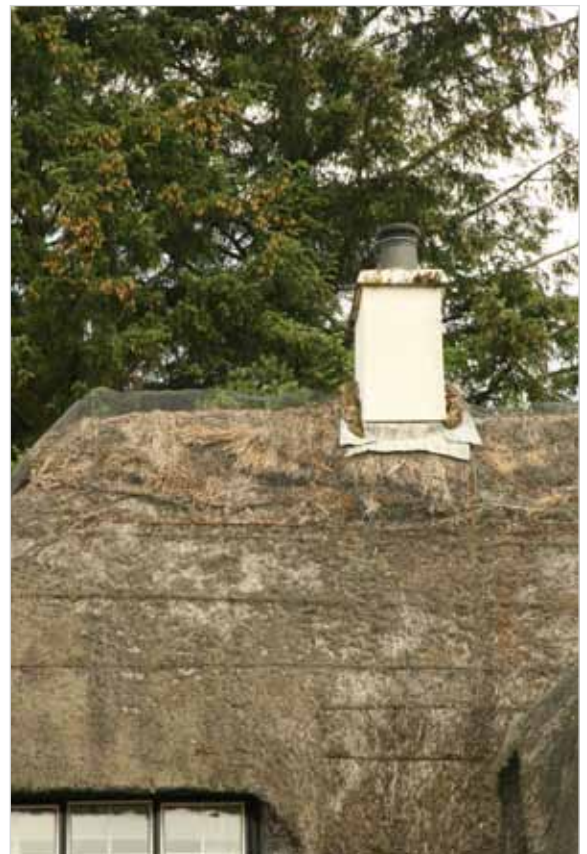
Drumwhirn – Stirling

**Additional Notes:** Listed as a '1930s English vernacular style' arts and craft house with a thatched roof. The thatch is reed and the owner stated it was last thatched around 20 years ago. There are signs of scobed thatch detailing underneath the windows, but this has significantly come away in most places. The thatch is netted all over, including over the thatched ridge, where it is higher than the thatch by perhaps a foot or so, demonstrating how much the thatch has compacted. There are patches of vegetation growth and loose thatch in places throughout. The thatch is held in place by horizontal metal poles and metal pegs in some places.

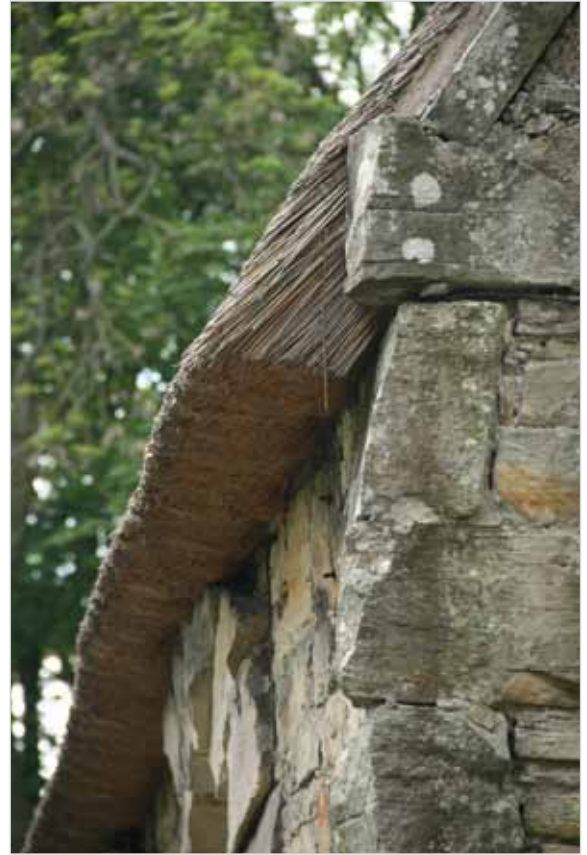
Obelisk Cottage – West Lothian

Additional Notes: ..... Possibly 18th-century cottage, thatched on the north, west and south elevations only, and piended on the west end. Both the building and thatch are in a good condition, with the building currently being used as a holiday let by the Hopetoun House Estate, within which it is located. There are two decorative bird sculptures fixed to the top of the ridge in the centre, made from thatch and netting. The thatched ridge is decoratively sculpted, scobed and netted.

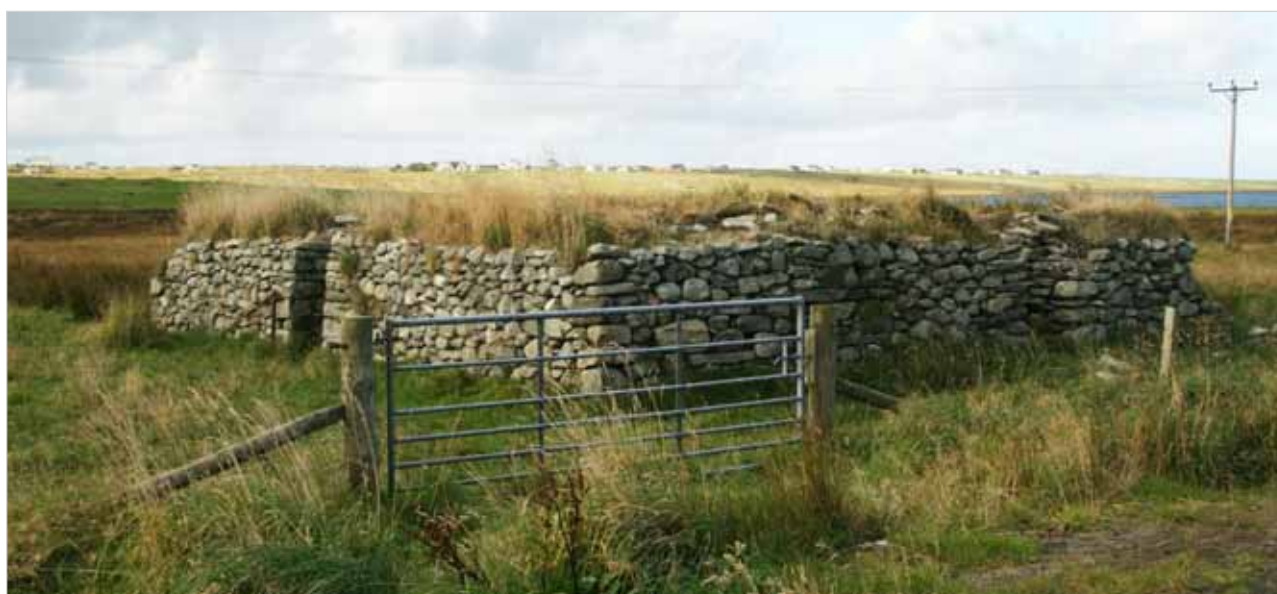
Additional Notes: ..... The listing description reads '*Hebridean-type thatch-roofed building*', however, this building is now a roofless ruin. It has been on the Buildings at Risk (BAR) Register since 2010 (BAR reference number 4757) and BAR inspection at that time noted '*external inspection finds the formerly thatched building now in an advanced state of decay*'. Photographs taken during the same visit by BAR in 2010 show the roof to be collapsed yet with some of the roof structure and thatch attached still visible. This is no longer the case and the roof has entirely collapsed into the shell of the building. The listing description for the building should be updated accordingly.

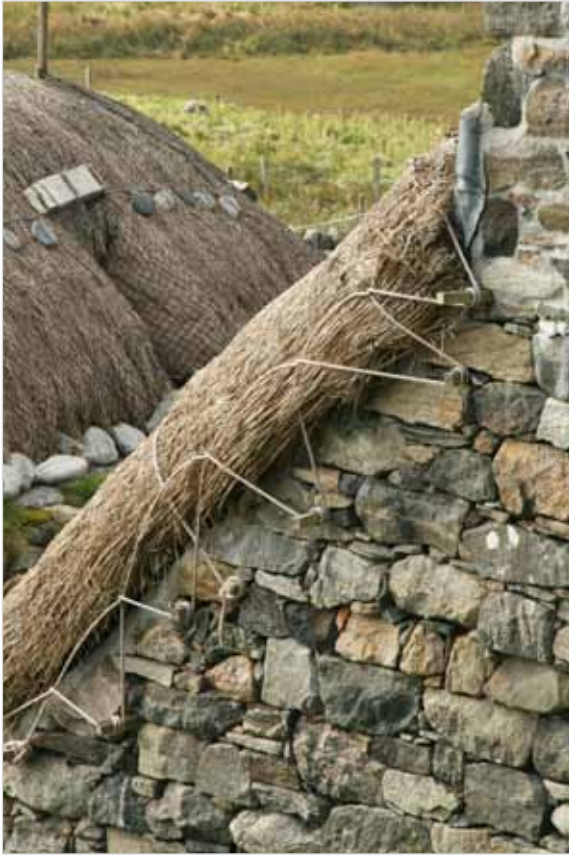
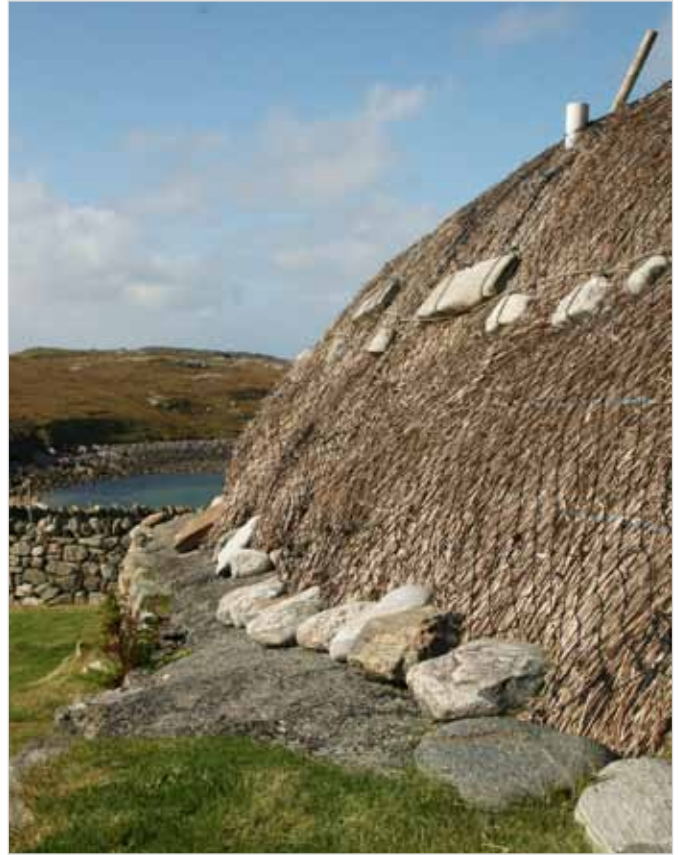
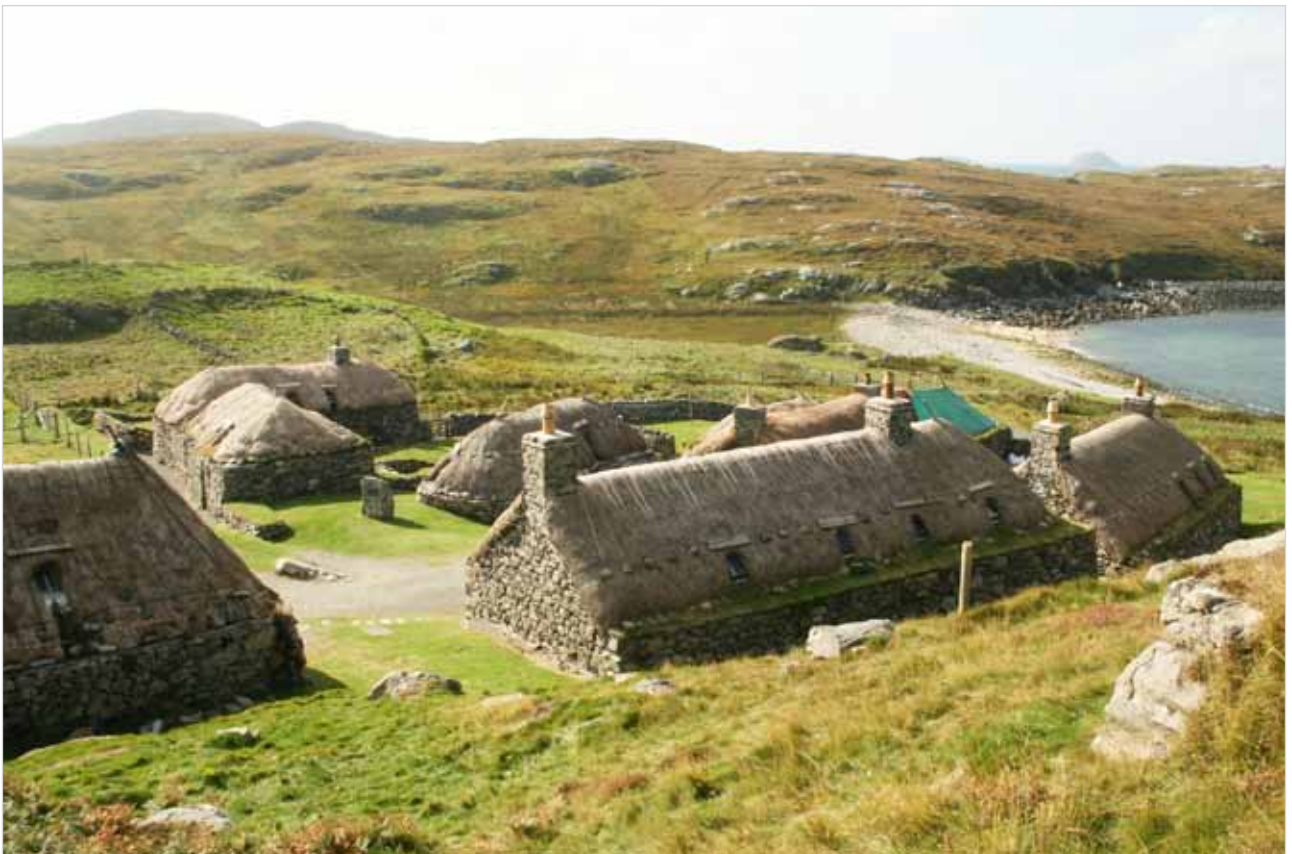
Gearrannan Blackhouse Village – Western Isles

Condition: ..... Good/Fair

**Additional Notes:** ..... The listed building description reads '*Group of traditional Hebridean-type cottages, built along either side of roadway leading towards Machair. Ten principal buildings, plus associated outbuildings. All thatched-roofed, originally but neglected to partial ruin; some houses being incrementally re-occupied 1980's-1990's.*' The village was once a crofting township and the last buildings were abandoned in the early 1970s. The buildings, of which there are currently 14, now form the Gearrannan Blackhouse Village and have a mixture of uses, including a museum, holiday accommodation, hostel, amenities, storage, shop and cafe. The buildings that are thatched are all thatched in straw with continuous straw ridges. The thatch on all buildings has been netted, which is weighted by stones and ropes, passed over the ridge vertically and also horizontally. Some of the buildings have wooden 'horns' protruding from either end of the ridge, used to tie some of the weighting ropes to. At the time of visiting, one of the cottages was being re-thatched and a plastic underlay could be seen underneath the thatch. Two of the buildings had tar felt roofs.

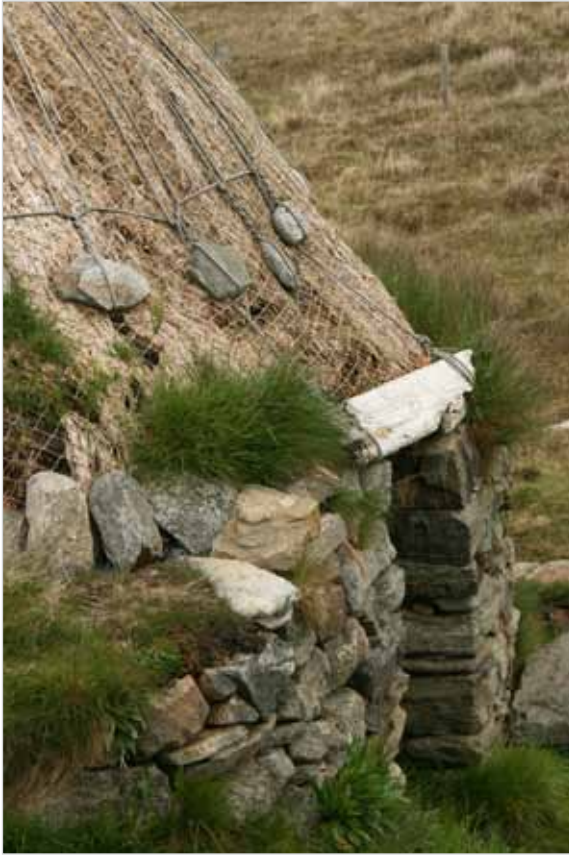
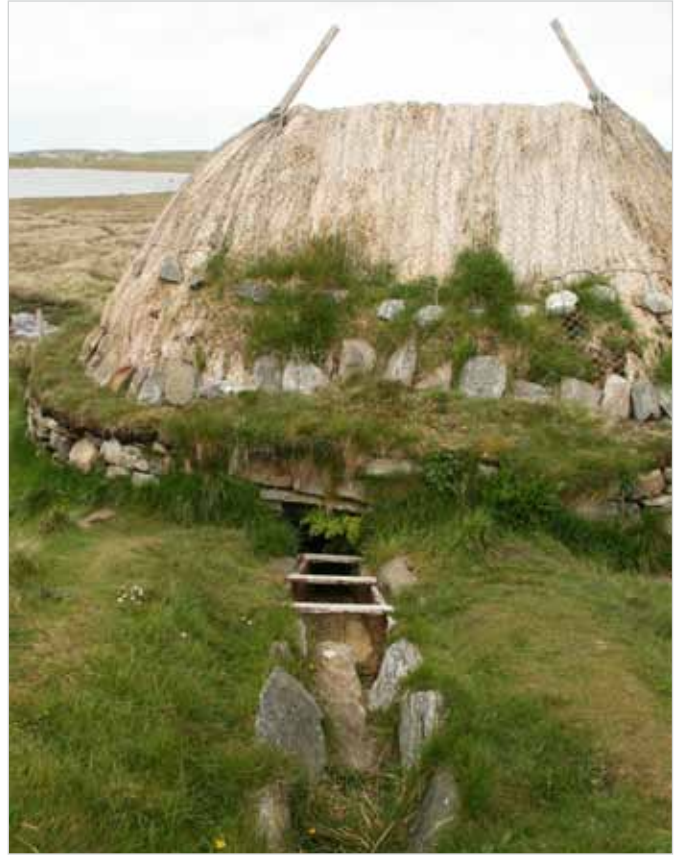
Norse Mill and Kiln – Western Isles

Condition: ..... Fair

**Additional Notes:** ..... An excerpt of text on Canmore explains that these two structures are a '*traditional thatched horizontal click mill and drying kiln*' that were used until the 1930s. The buildings were restored in the late 1960s but again fell into disrepair until they were '*reconstructed in 1996 by Stuart Bagshaw & Assoc. for the Norse Mill Society*' (Miers, M. (2008), *The Western Seaboard: an illustrated architectural guide*. Edinburgh). Both structures are oval in shape and have a straw-thatched roof with a continuous straw ridge. The roof has been entirely netted, including across the ridge, which has been weighted down with stones and rope. There is a continuous string of stones around the middle of the roof horizontally, attached to vertical ropes that pass over the ridge and down the other side. Twin 'horns' protrude from either end of the ridge and are used to secure some of the ropes for weighting the stones. The netting is additionally weighted by stones placed on the edge of the netting along the wallhead, which is additionally weighted with turf. In some places, the turf from the wallhead has begun to grow up onto the straw thatch, particularly upon a lower area of the south elevation. The buildings are not occupied but are open to the public for viewing as an example of a once common building type on the Western Isles.

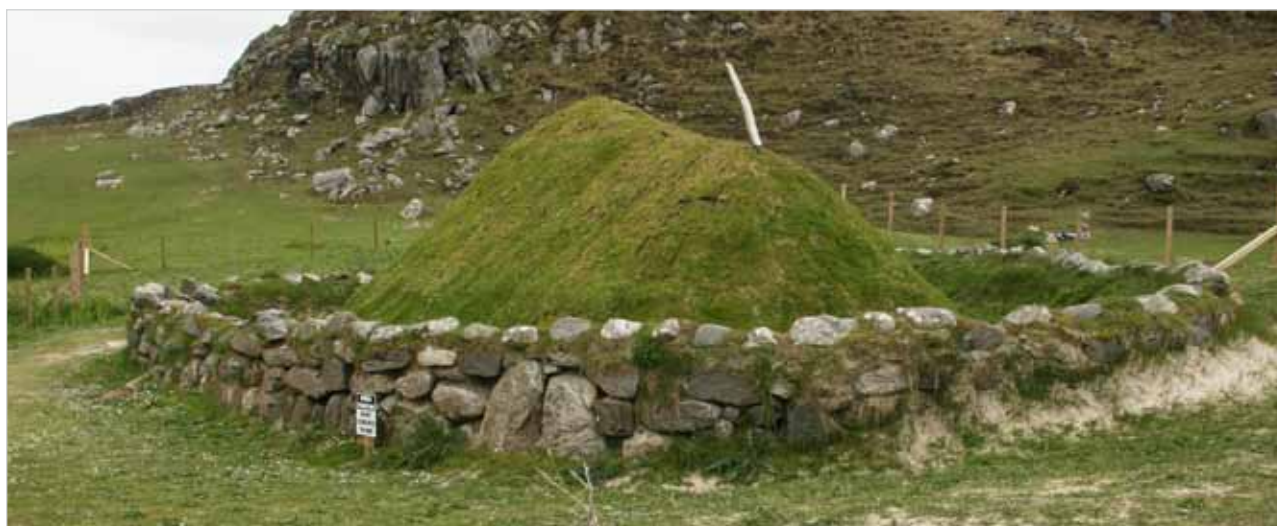
**Additional Notes:** ..... Reconstruction roundhouse, built in 1999 after an Iron Age village settlement was discovered nearby in 1993, with exavations taking place in 1996. The original houses, which have now been re-covered with sand for protection, are thought to date from 400-800 AD and this house was reconstructed for visitors. The building was at one time thatched and secured with rope and stones for weighting, as described and seen in photographs online advertising the site. However currently the building's roof has a turf covering and there are no longer any ropes or stones present. The wooden 'horns' at either end of the ridge, usually used to secure ropes for thatching, are still present. It is unclear whether the thatched roof has been removed permanently or whether the building is in a phase of maintenance.

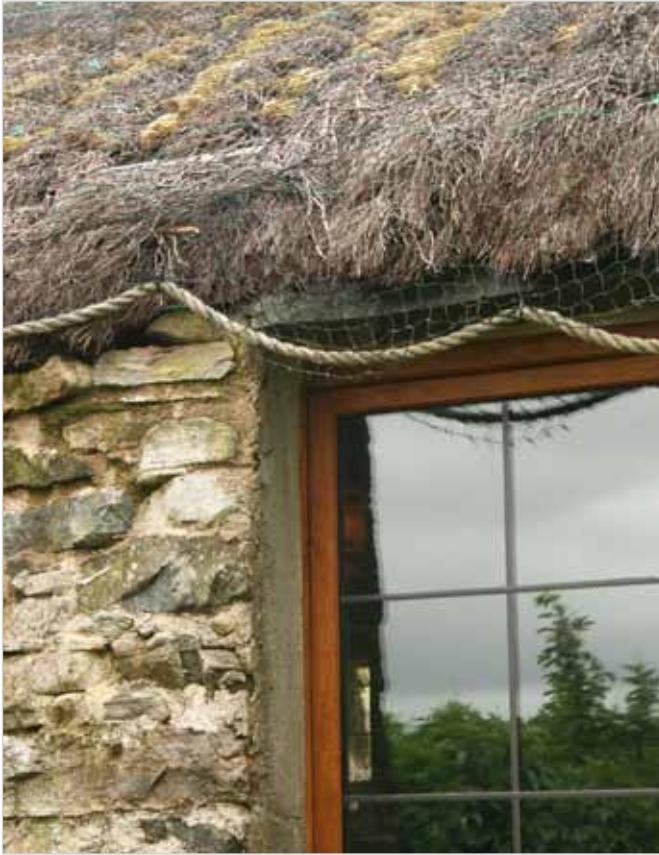
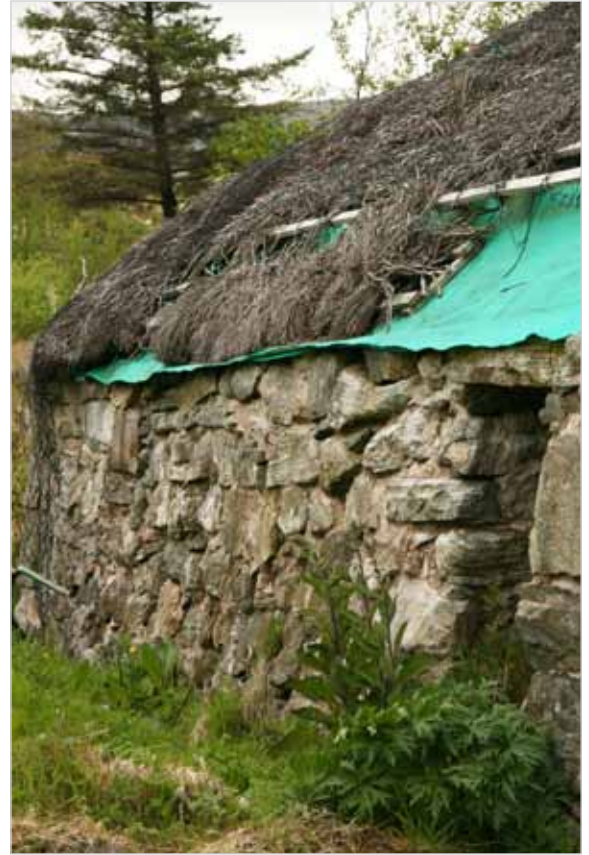
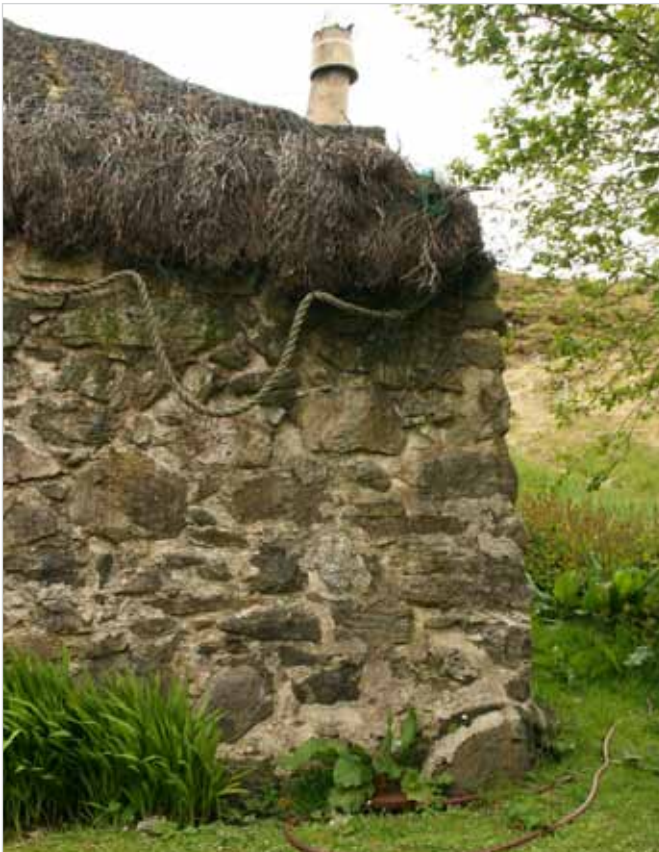
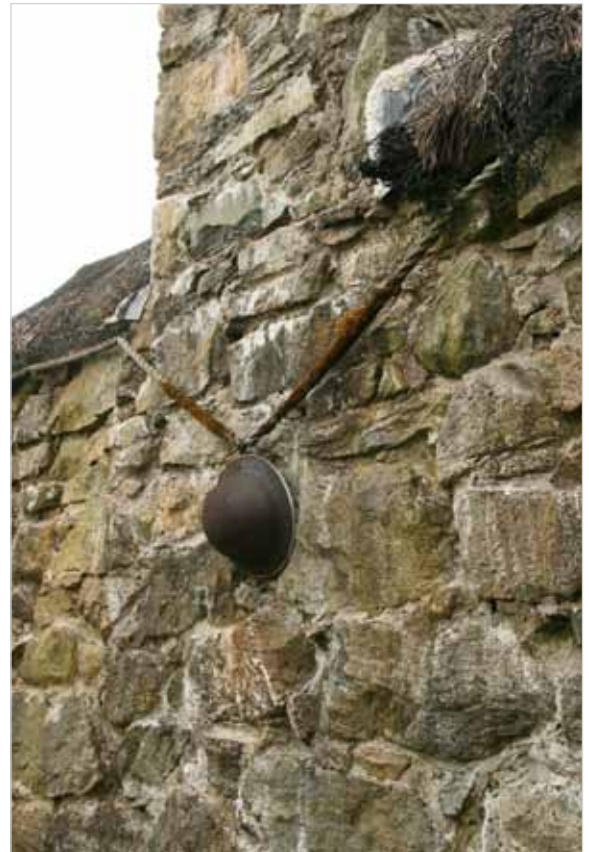
Lickisto Blackhouse – Western Isles

Condition of Thatch: ..... Fair

Additional Notes: ..... Cottage building of unknown date, located within a camp site and used for cooking and common room facilities for guests. The roof is thatched in heather and has a continuous heather ridge. The roof has been entirely netted, including across the ridge, which has been weighted along the ridge by rope passed through the holes in the net. The net has been secured to the wall at either gable end by metal pegs. The thatch on the rear elevation is substantially missing and exposes much of the roof structure and plastic sheeting beneath. Across the surface of the remaining thatch there is some mossy vegetation growth throughout.

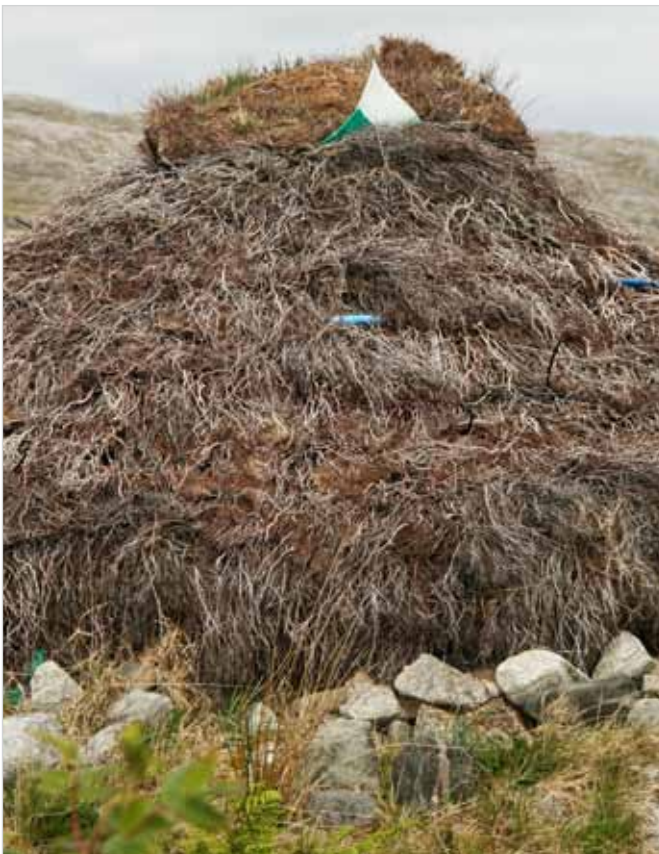
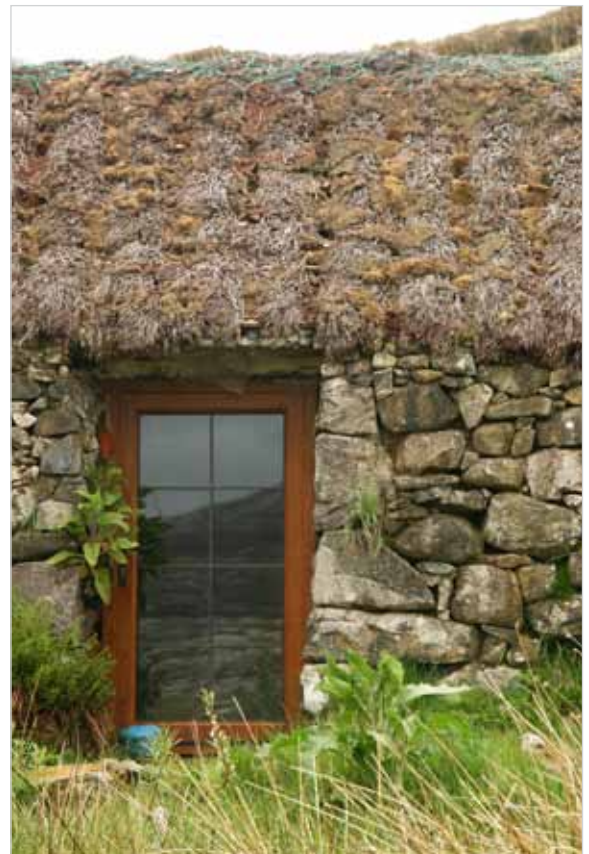
Lickisto Byres – Western Isles

Condition of Thatch: ..... Poor

byre and string on the east byre. The rear elevation of the east building is in poor condition and much of the thatch

is missing, particularly lower down, which is exposing the roof structure and plastic sheeting underneath. There

is also some mossy vegetation growth across the

surface of the thatch throughout both roofs. ....

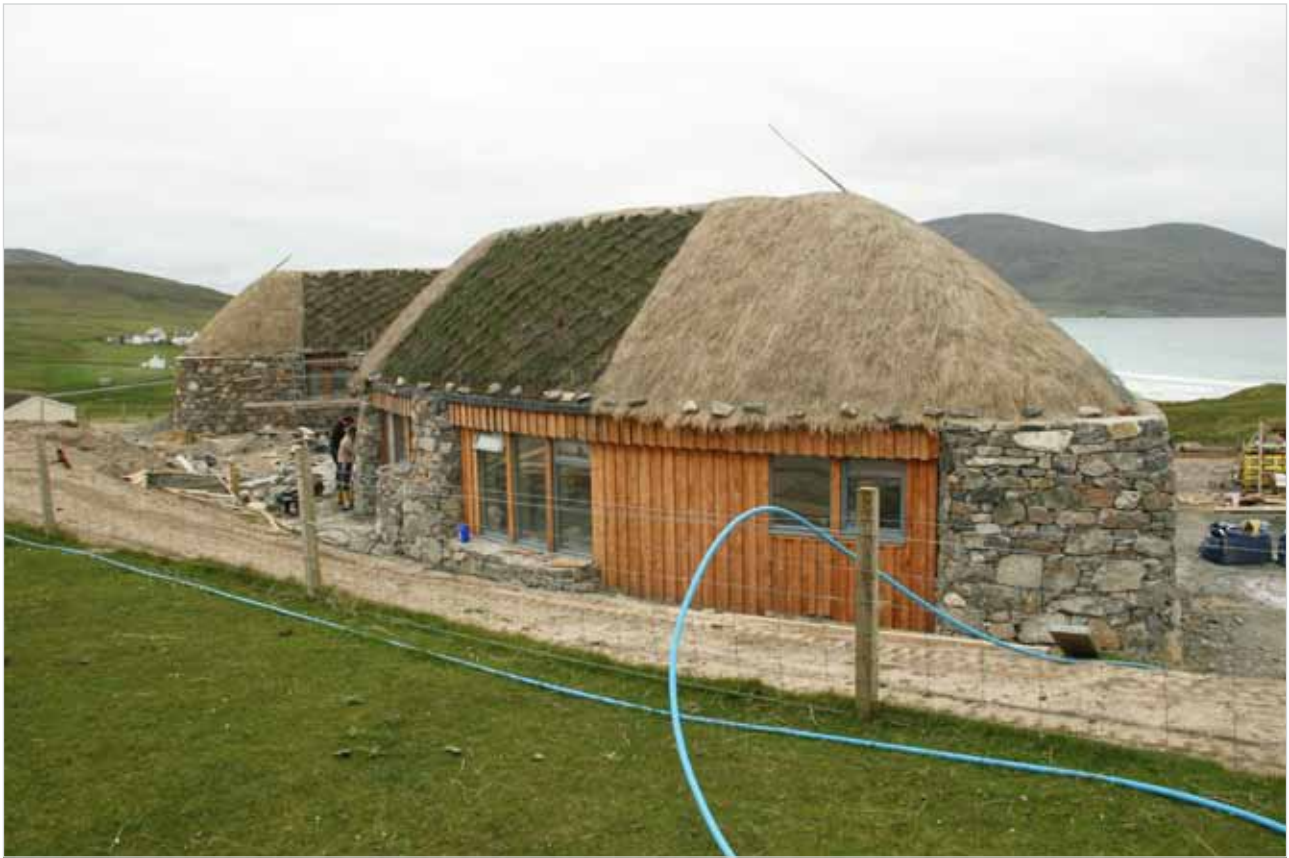
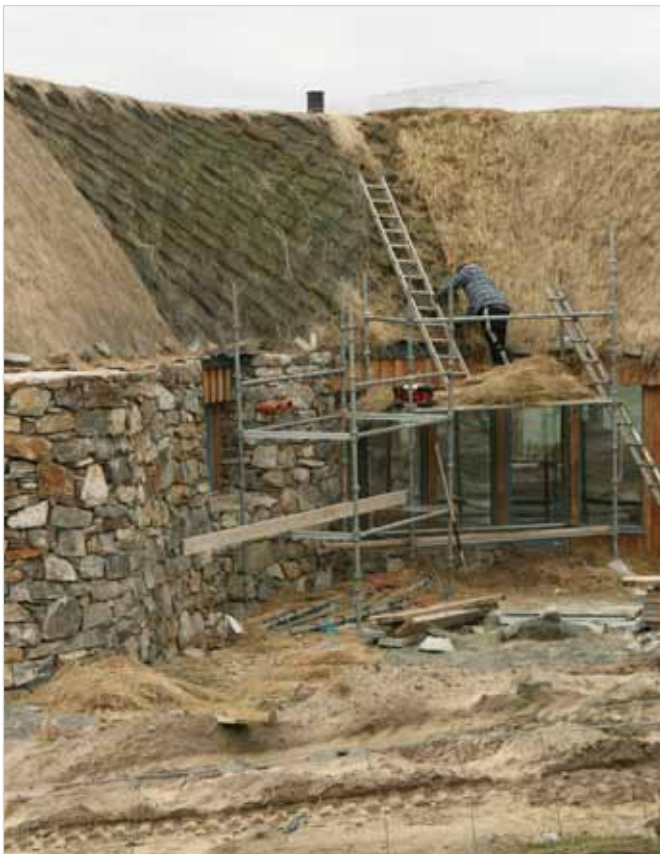
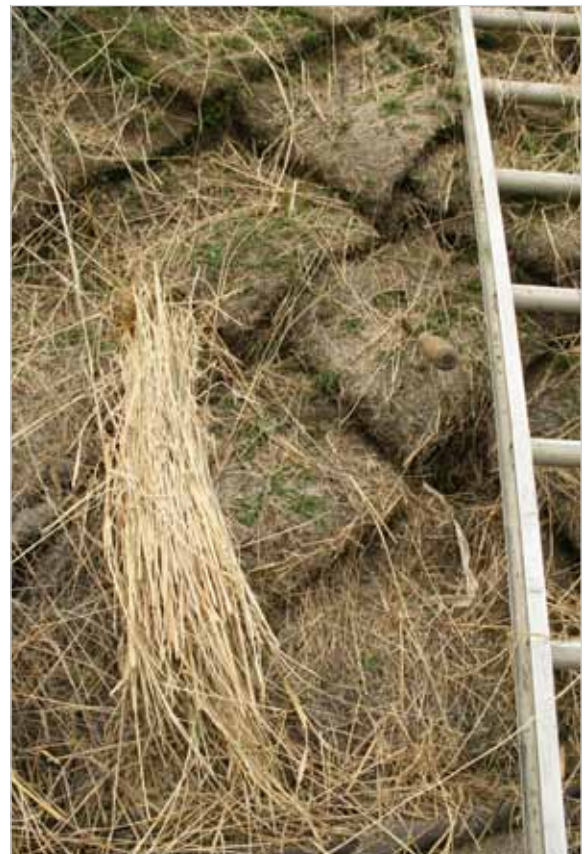
Oran na Mara – Western Isles

Condition of Thatch: ..... Good

will be the final method of weighting is unknown.

The pitch of the roof varies throughout due to the curvature of the building.

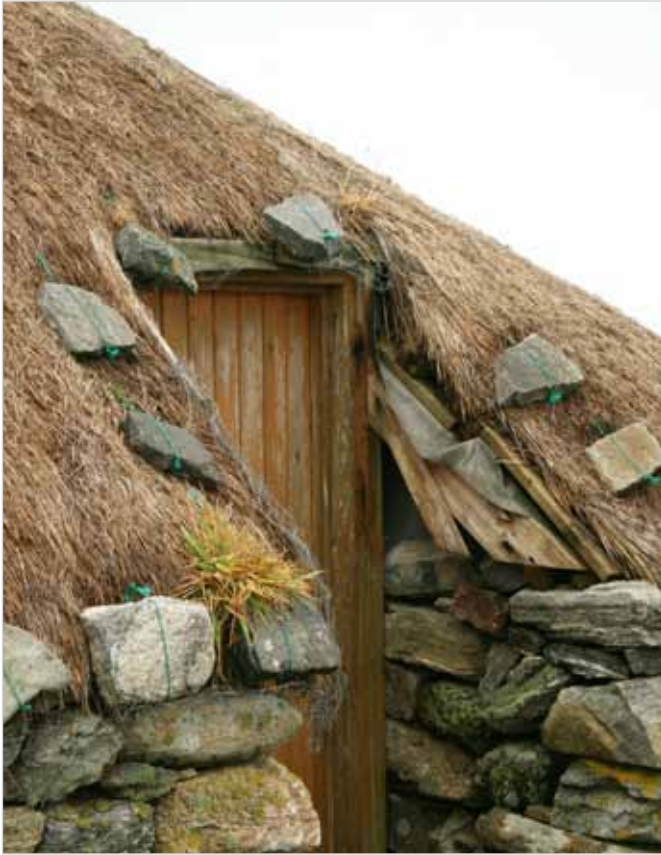
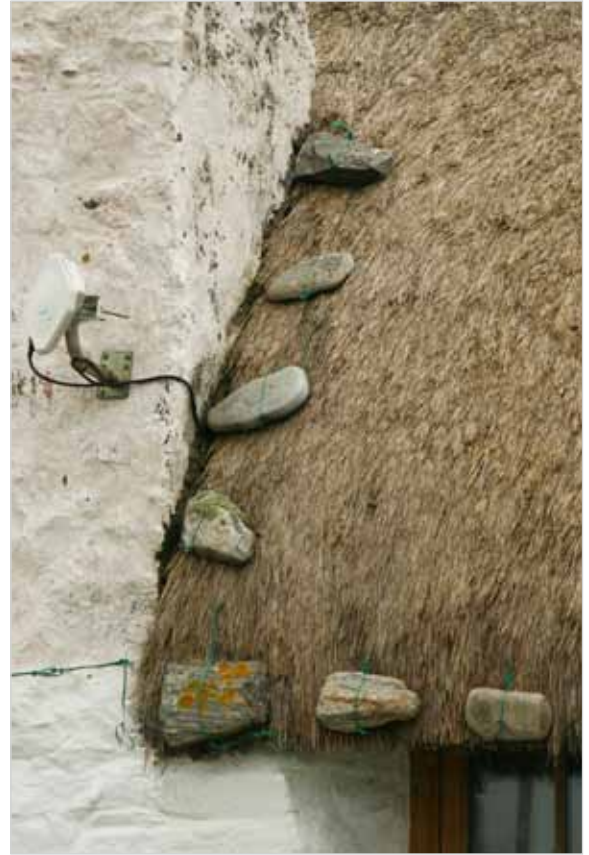
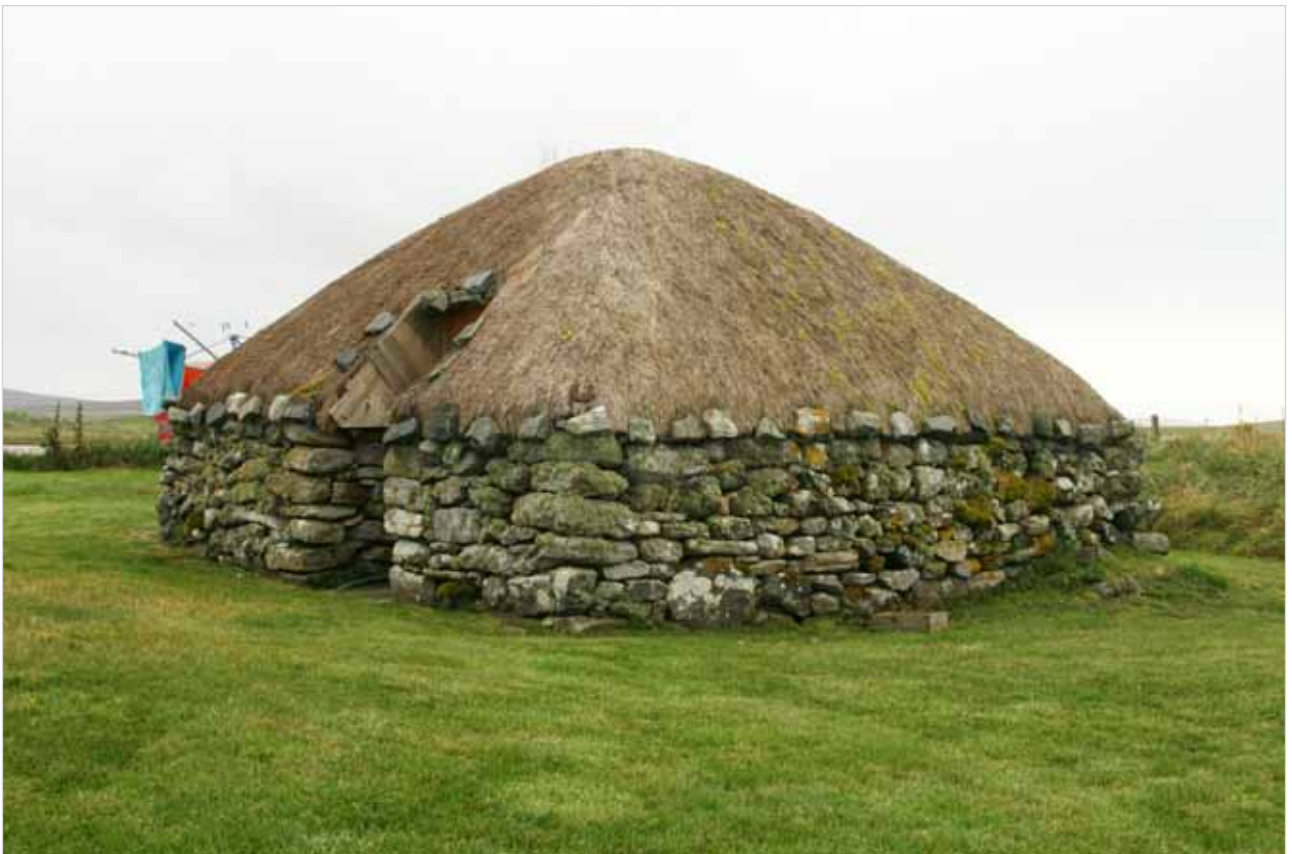
Boreray Cottage – Western Isles

..... Good

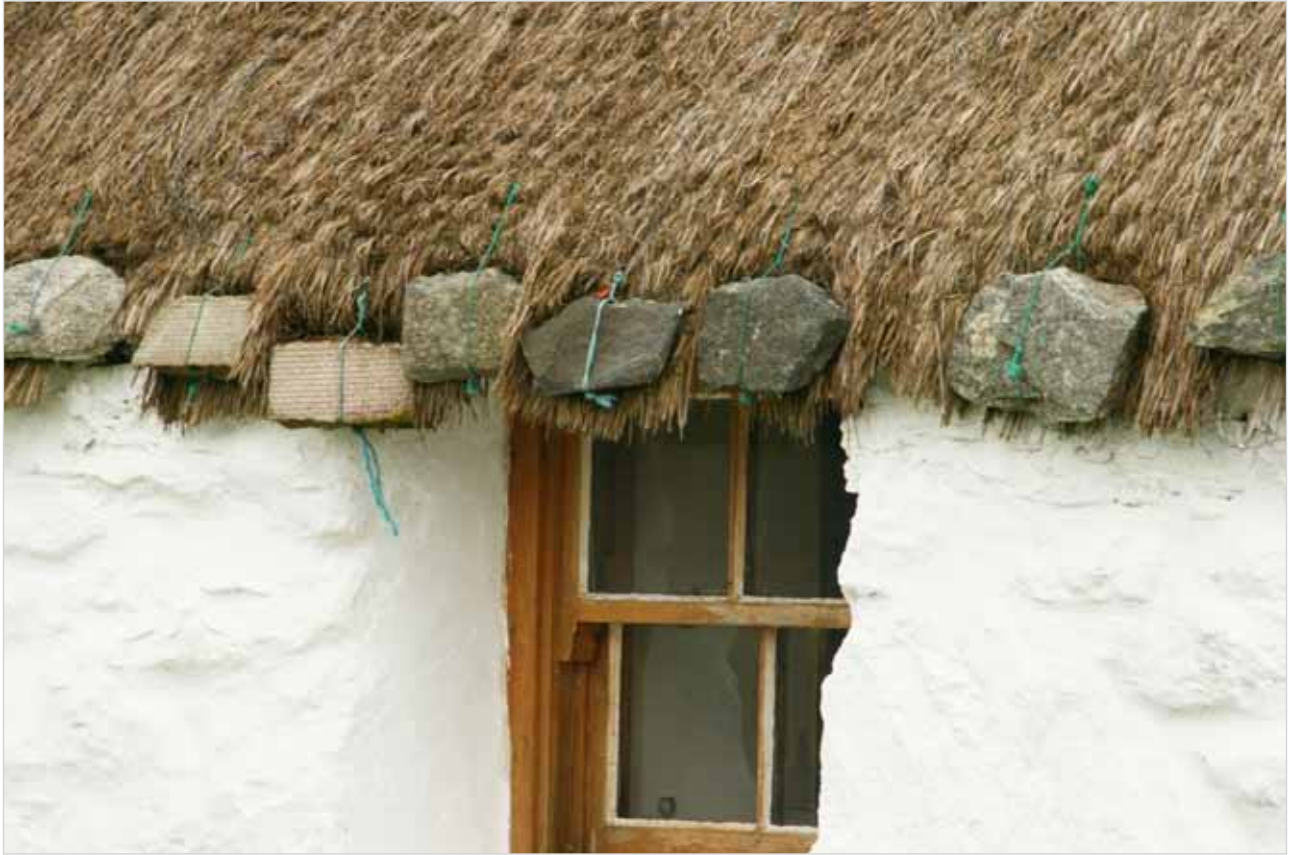
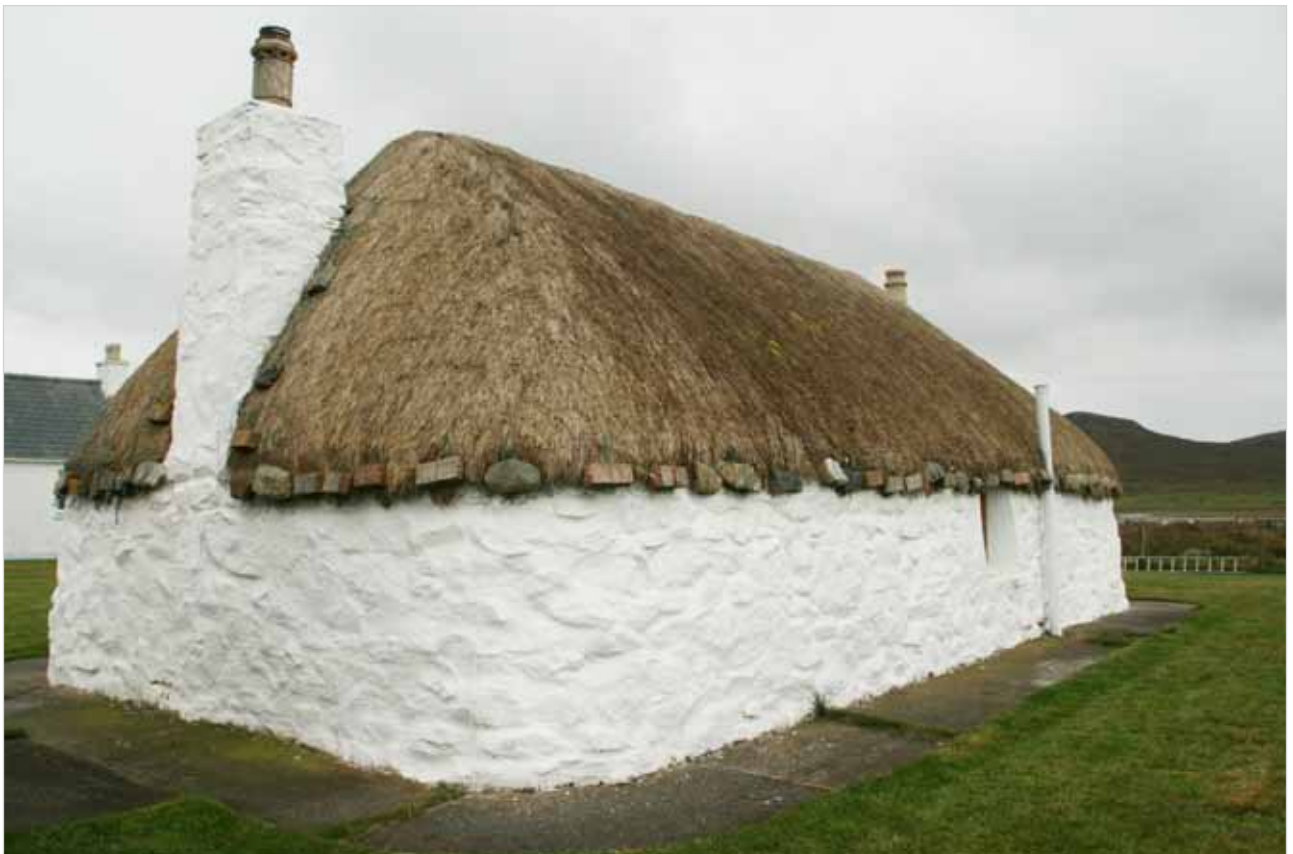
Tigh na Boireach – Western Isles

..... Good
